Tinker's Creek Watershed

2020 Water Quality Report

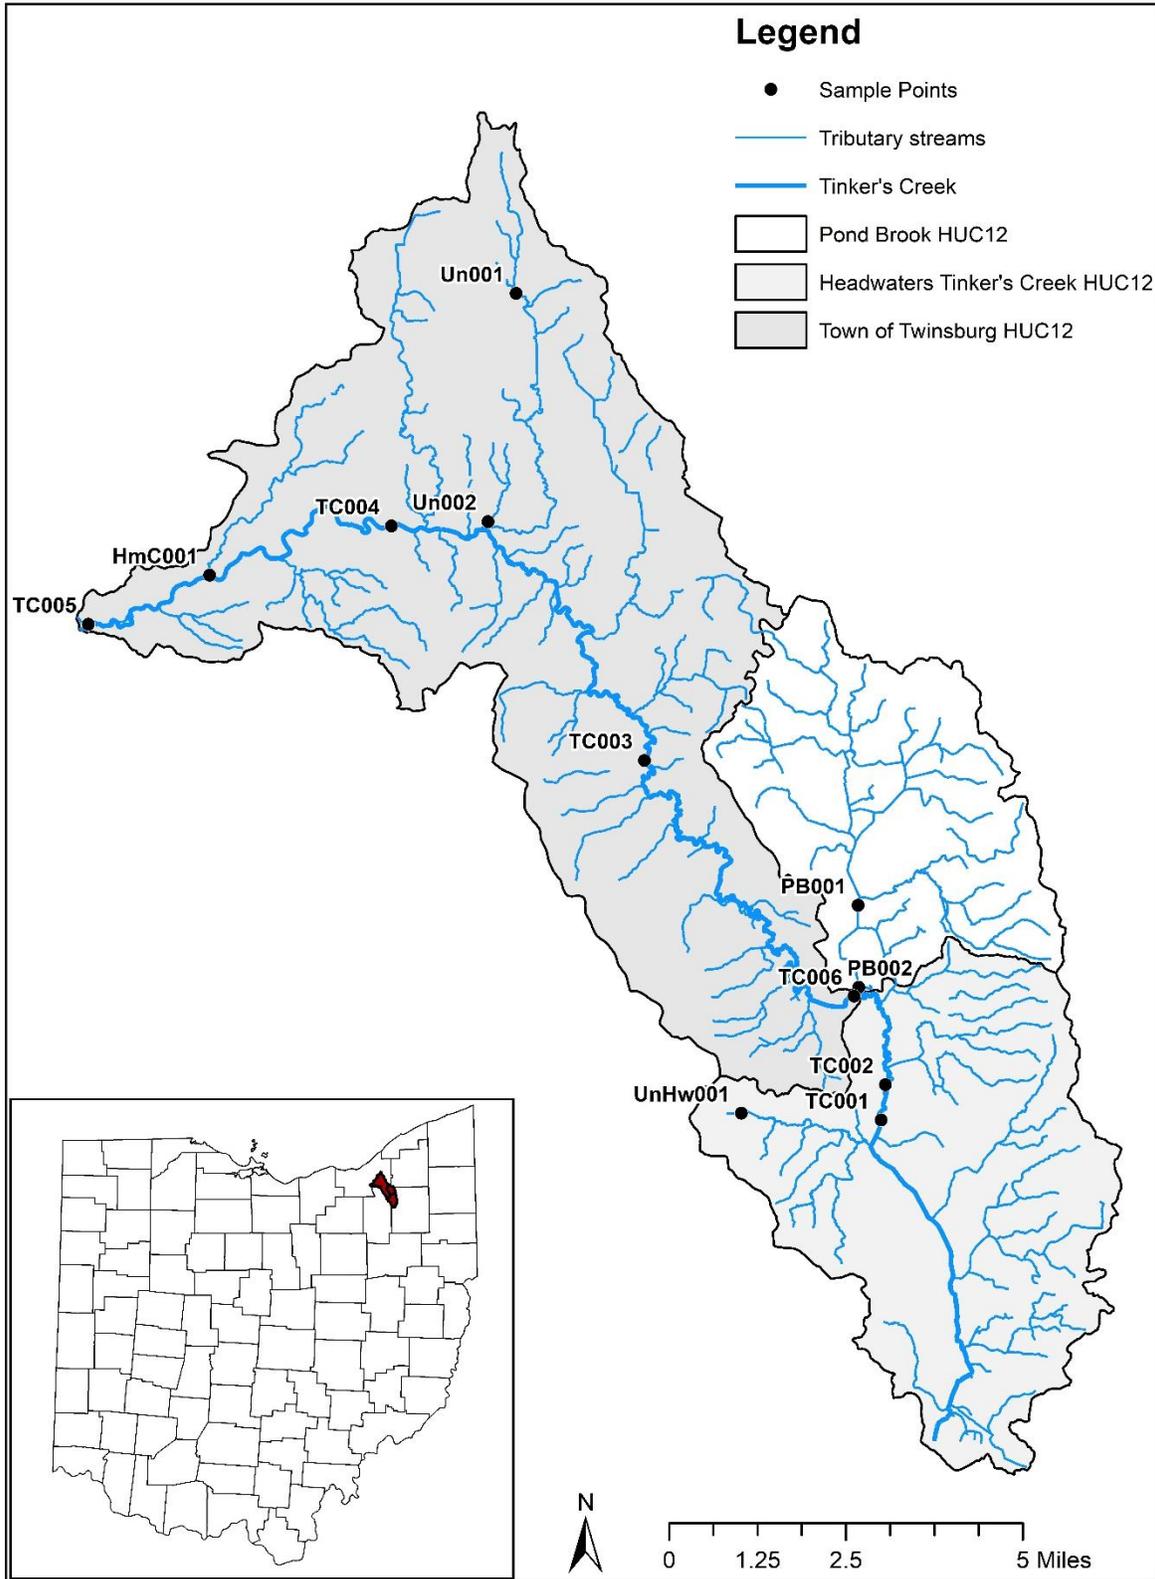
2020 Water Quality Sites Map

Using volunteer and staff assistance, TCWP sampled 12 sites between May and September, 2020 (Table 3). These sites are located throughout the watershed from the headwaters to the confluence of Tinker's Creek and the Cuyahoga River. A map of these sites is provided on page 10. Of these 12 sites, one site was undergoing stream restoration projects in 2020 (Bedford Heights Bus Garage Project).
