Tinker's Creek and Brandywine Creek Watersheds 2023 Water Quality Report

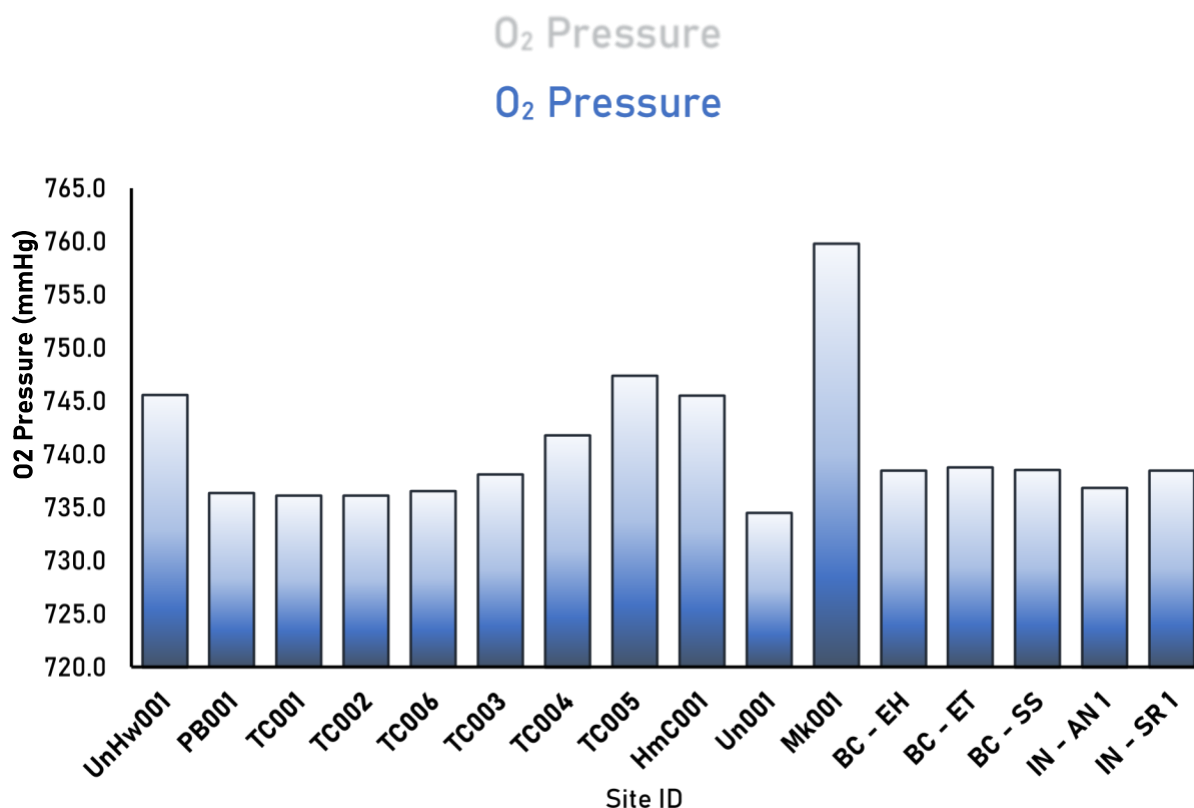
Oxygen Pressure is measured in mmHg. It is not a standard measurement that we use in reporting; however, it is helpful when looking at the Dissolved Oxygen of freshwater. Generally, an increase in O₂ pressure is correlated with an increase in dissolved oxygen.

Figure 6. The average partial pressure of oxygen in the water at each sample site.

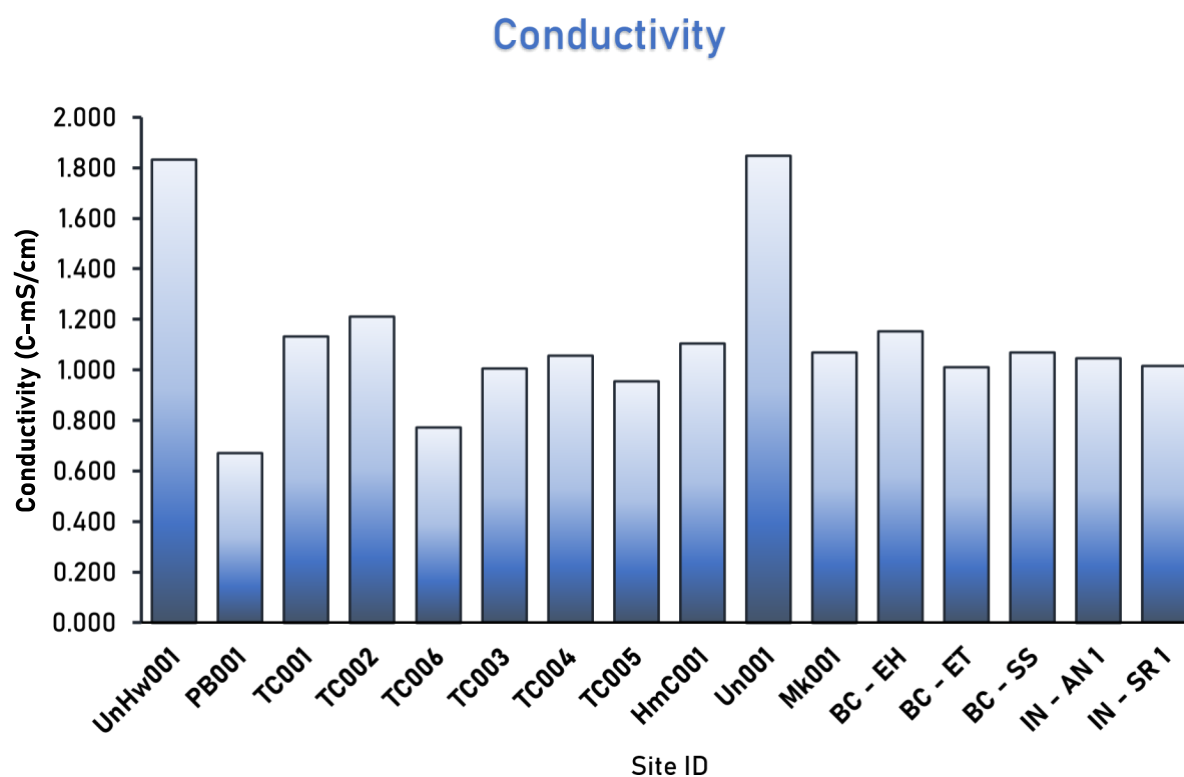
Conductivity is the measurement of waters ability to pass an electrical current. As dissolved salts such as Chloride conduct electrical current conductivity increases as salinity increases. It is completely expected that site Un001 would have the highest average conductivity reading as it also displayed the highest average level of Chloride.

Figure 10. The average conductivity for each sample site.
