BRANDYWINE CREEK

04110002 04 04 Brandywine Creek (HUC 12)

Nine-Element Nonpoint Source Implementation Strategic Plan (NPS-IS Plan)

Tinker's Creek Watershed Partners
P.O. Box 444
Twinsburg, OH 44087

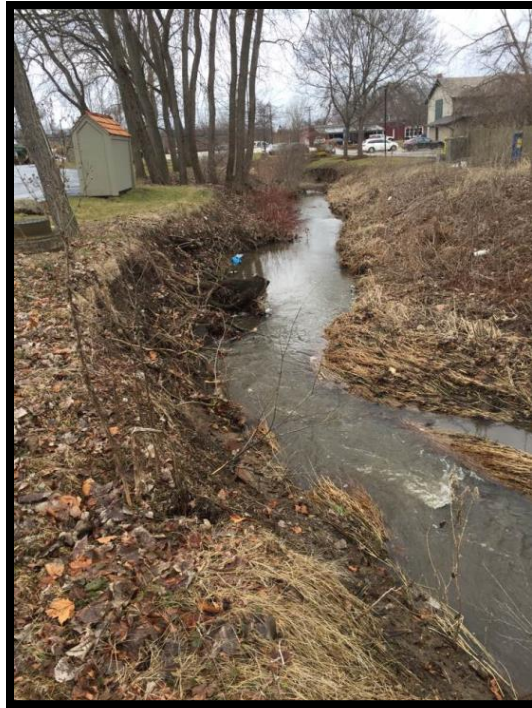
Figure 9: Brandywine Creek looking downstream just above Route 91/downtown Hudson, Summit County, some erosion present.

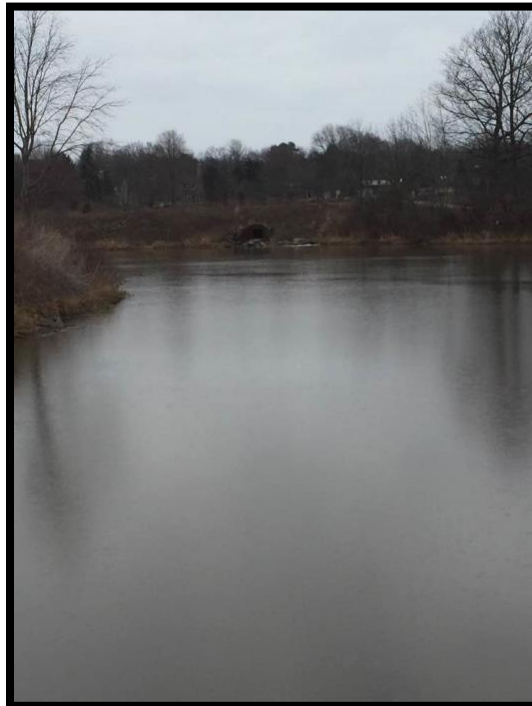
Figure 10: Viewing the inlet from the outlet of Lower Dam, Hudson, Summit County, these dams potentially effect water quality downstream.

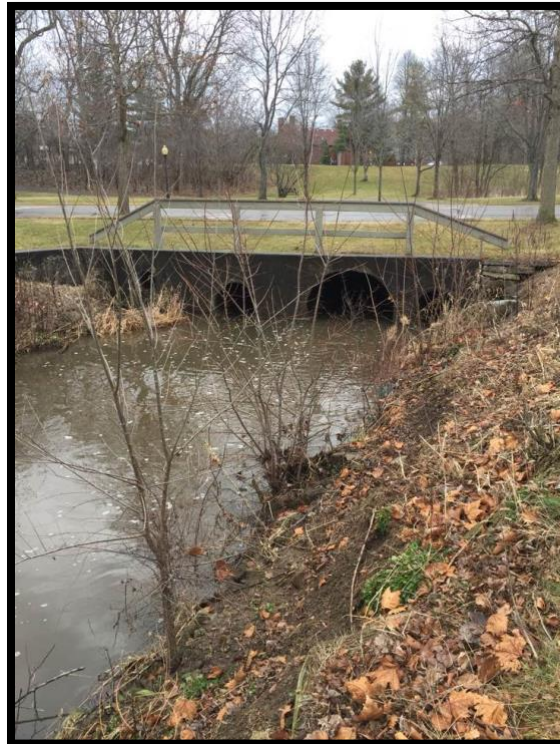
Figure 11: Brandywine Creek; In-stream habitat example with culverted stream section; Ravenna St., Hudson, OH

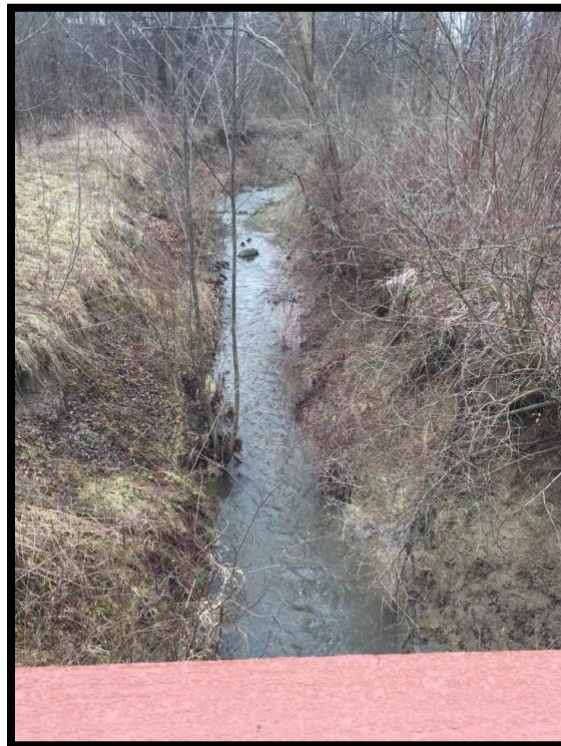
Figure 16: Looking upstream, inlet to Upper Lake Dam, Hudson, Summit County, the creek is incised here with eroding banks.

In addition, Brandywine Creek experiences very high sediment loading caused from significant increases in storm water loading, which is correlated to the high amounts of developed land in the watershed (65.40%). Brandywine Creek watershed, like most urban watersheds, continues to experience a net loss of habitat both for terrestrial and aquatic species alike. The “unknown toxicity” alludes to a water quality degrader which is of unknown composition. Evidence of pharmaceutical compounds negatively influencing aquatic biology is being studied as a direct cause of the unknown impairments.

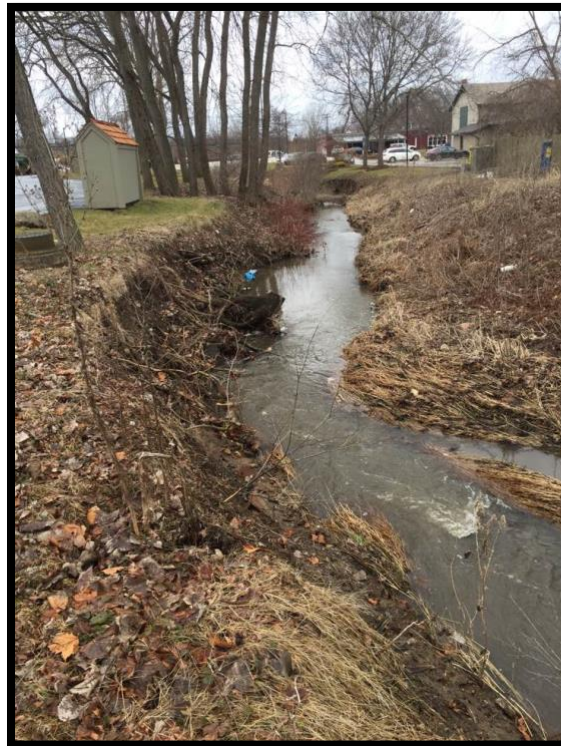
Figure 18: Brandywine HUC-12, example 'typical' of Critical Area 1

Critical Area 1 reaches across the middle belt of the watershed from northwest to southeast. It contains the bulk of the wetlands, forests, and critical soils that are a priority to protect and conserve.

Detailed assessments of headwater streams within the watershed are limited. It is fair to assume that the number of primary headwater streams (<1 square mile in drainage) has decreased since pre-settlement. These small streams are often lost due to development.

Figure 18: Brandywine HUC 12: Example of “typical” Critical Area 1
